Lotus Elan M100 Service Bulletins
Series 1 and Series 2 1990 - 1996

SERVICE BULLETIN

TITLE: Replacement of headlamp flap 'J' links.

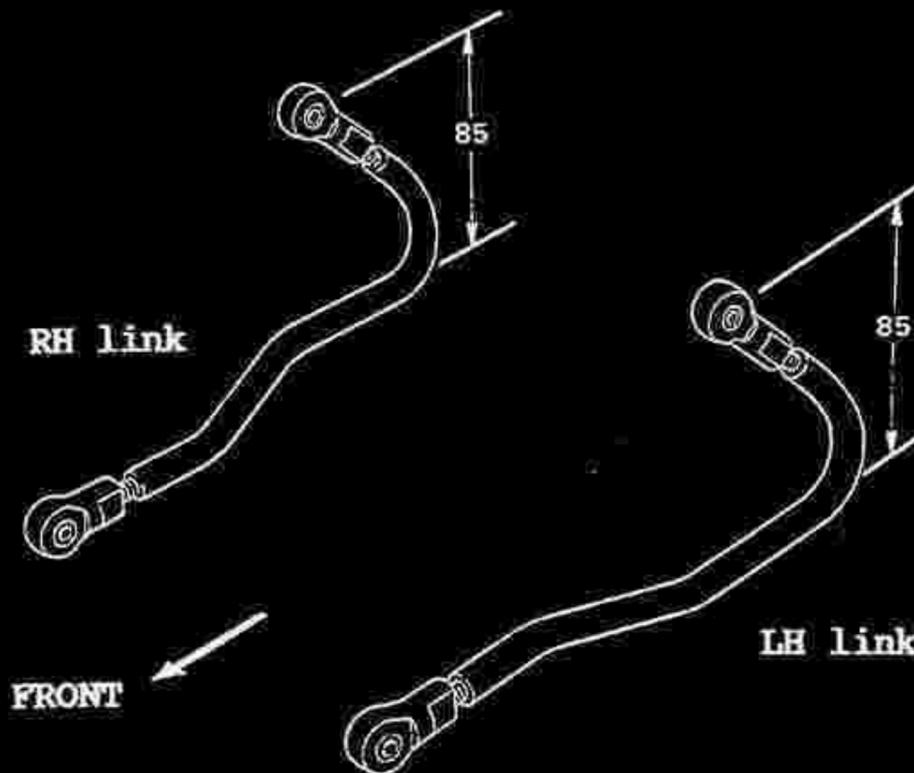
REASON: Incorrect material specification of some links may result in distortion of link and faulty operation of headlamp mechanism.

Before fitting the 'J' links, ensure that each link is correctly identified and adjusted as shown in the diagram.

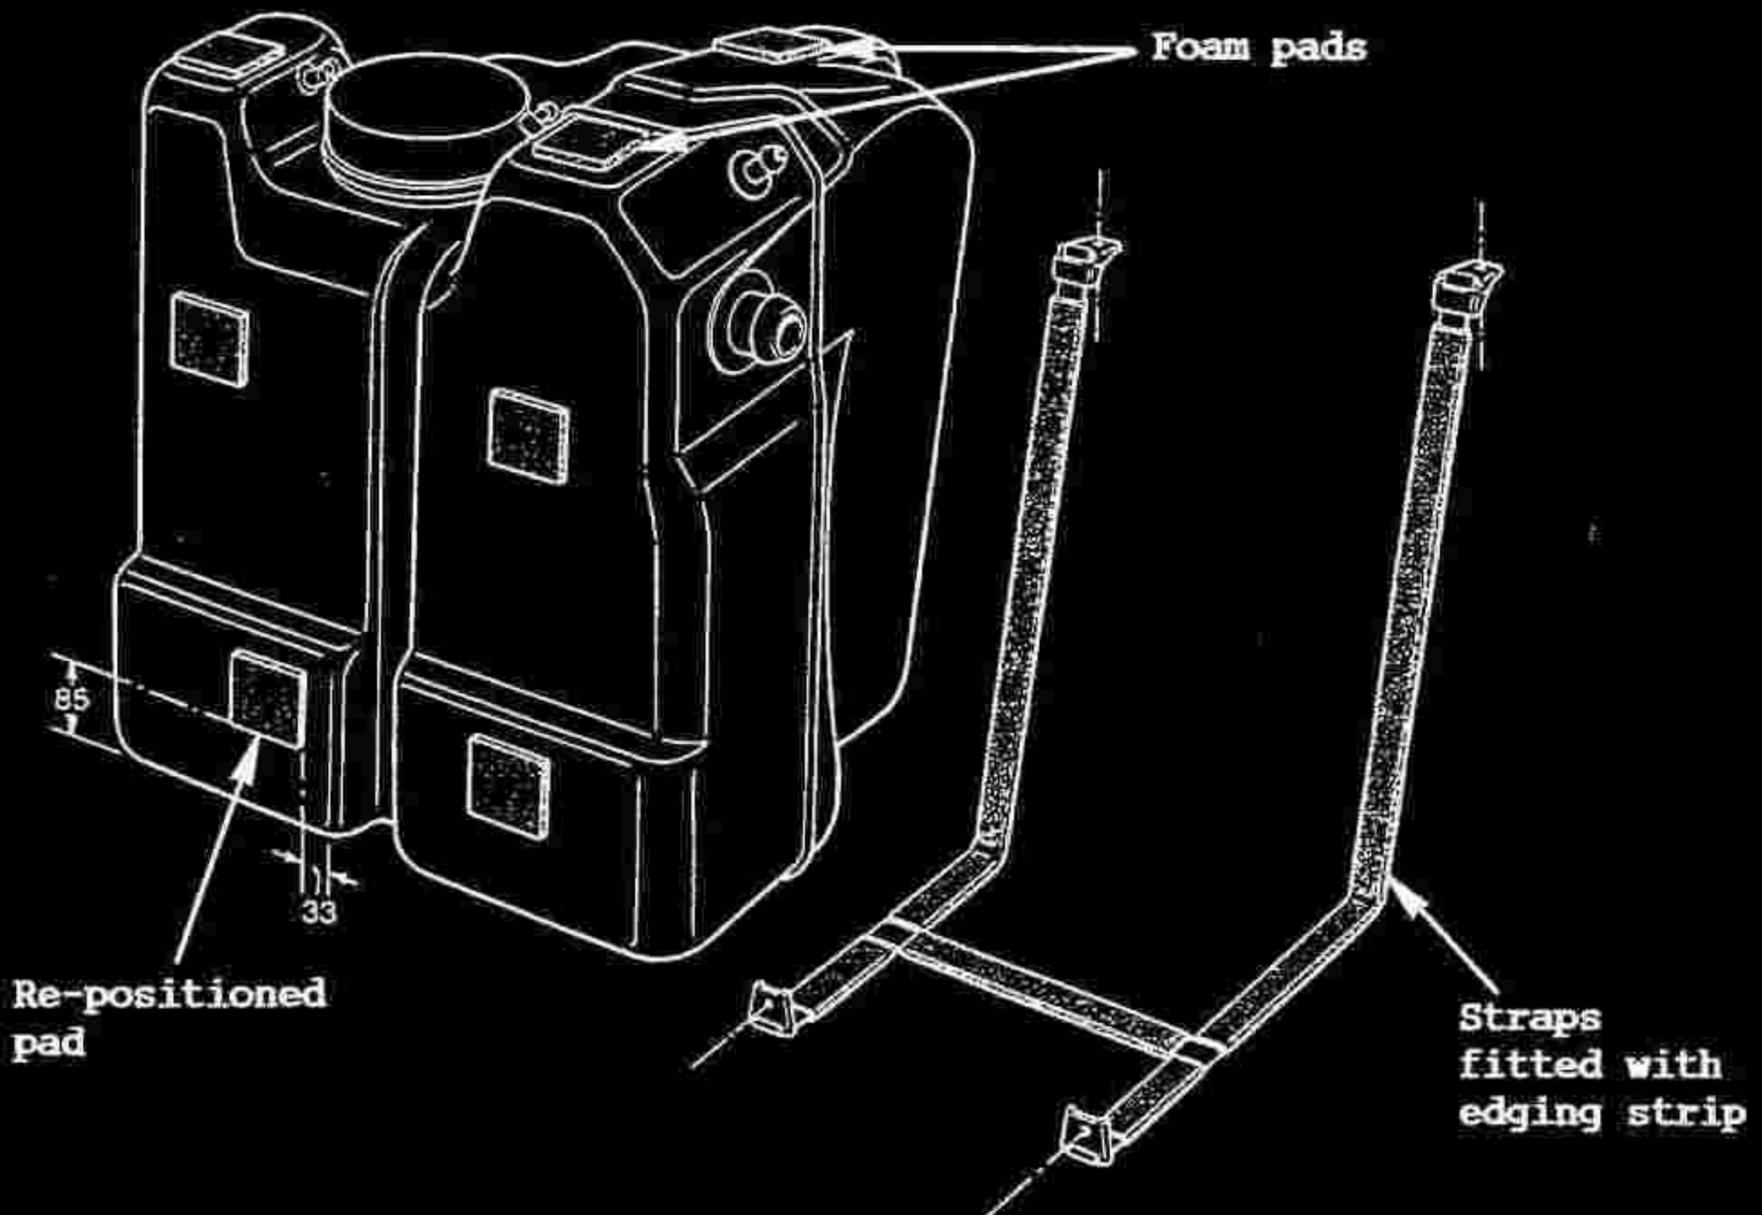
REASON: Revised moulding with improved resistance to joint line leakage.

- Release the anti-roll bar from the lower wishbone, and the bolt securing the anti-roll bar hanging link to the chassis. Remove the damper to lower wishbone bolt, and lower the wishbone and hub carrier assembly without straining the brake hose.
8. Release the locknut from the underside of the two strap top fixing bolts, and unscrew each bolt. Swing down the two straps and carefully lower the tank, easing the filler stub through the body.
 9. Transfer the balance pipe to the new tank, but leave one end disconnected.
 10. Use Silastic RTV 732 adhesive (A036E6038) to secure the seven foam rubber pads to the new tank in the positions shown on the diagram. Note that all the positions except the RH lower position on the tank front face are indicated by moulded corner lines on the tank.

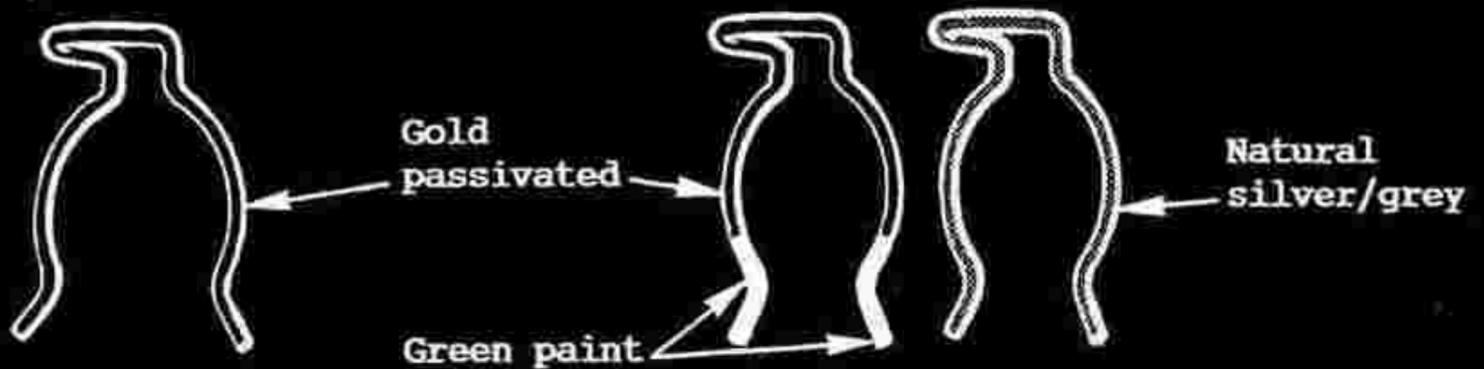
Preferred Types

REASON: Improved gearchange cable security.
The outer sheath of each of the two gearchange cables, is retained at each end by a spring clip. The spring wire clip used until recently, has been replaced by a dished 'C' clip which offers greater assurance of correct fitment, and increased resistance to dislodgement from the effects of vibration or vigorous gearchange operation.

If non preferred type clips are found to be fitted at the transmission end, it should be assumed that these also will be fitted at the gear lever end, and all four clips should be replaced with preferred types (A100F6060F).

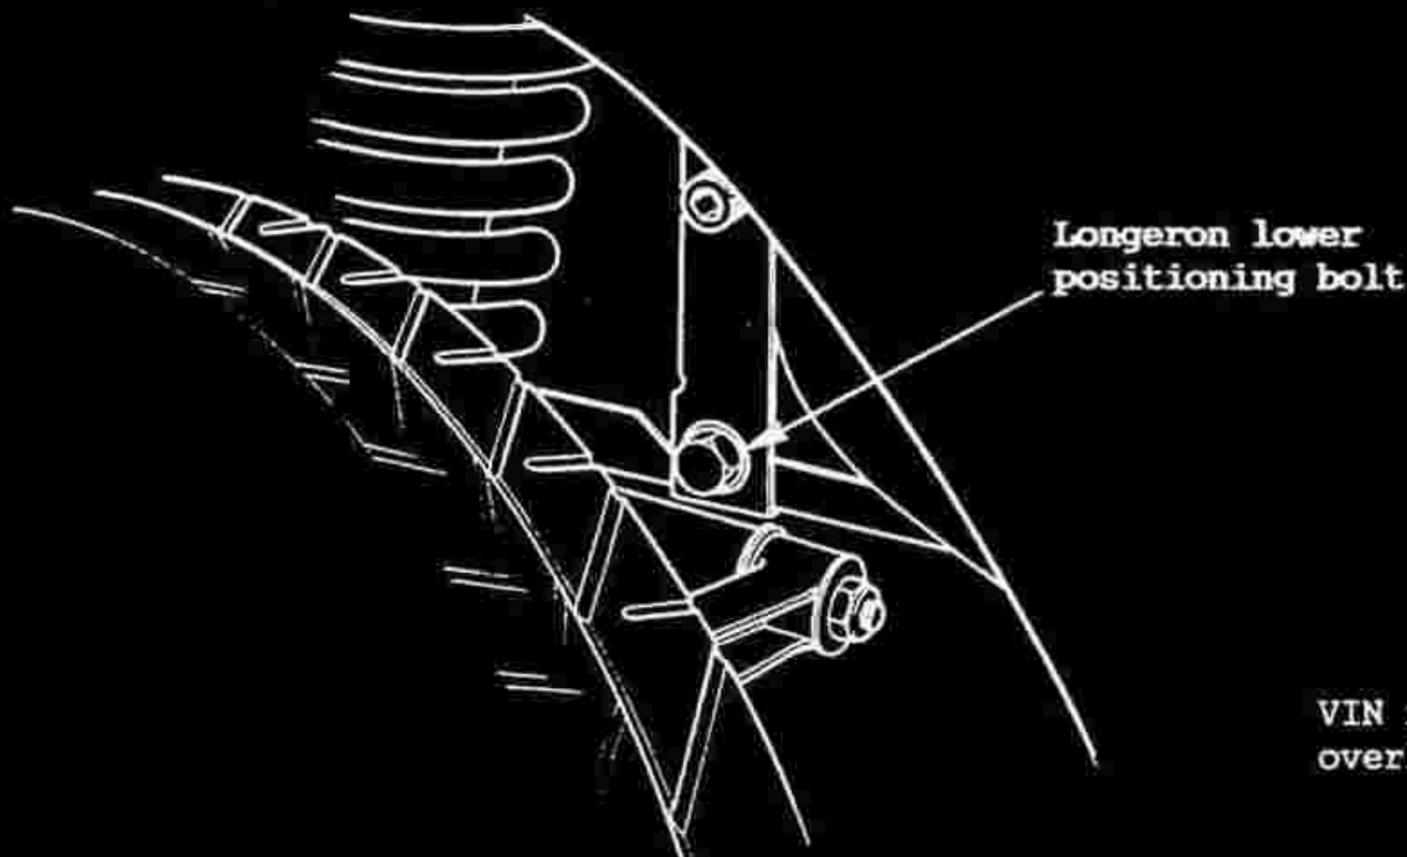
REASON: Bolts fitted may be below specification. It has been found that on certain cars, the lower (longer) of the two taper seat bolts used to position each chassis longeron before the six socket head bolts are tightened, may have been from a batch identified as not meeting the correct material specification.

1. With the car on its wheels, turn the steering for improved access to the lower front bolt (hex head) securing the longeron to the chassis. Note that it is not necessary to release the wheelarch liner.
2. Remove the bolt, and replace with a new bolt B100A0438F. Torque tighten to 120 Nm (89 lbf.ft).
3. Mark the head of the new bolt with BLUE paint. Note that the old bolt may have been marked with GREEN paint.
4. Repeat for the opposite side.

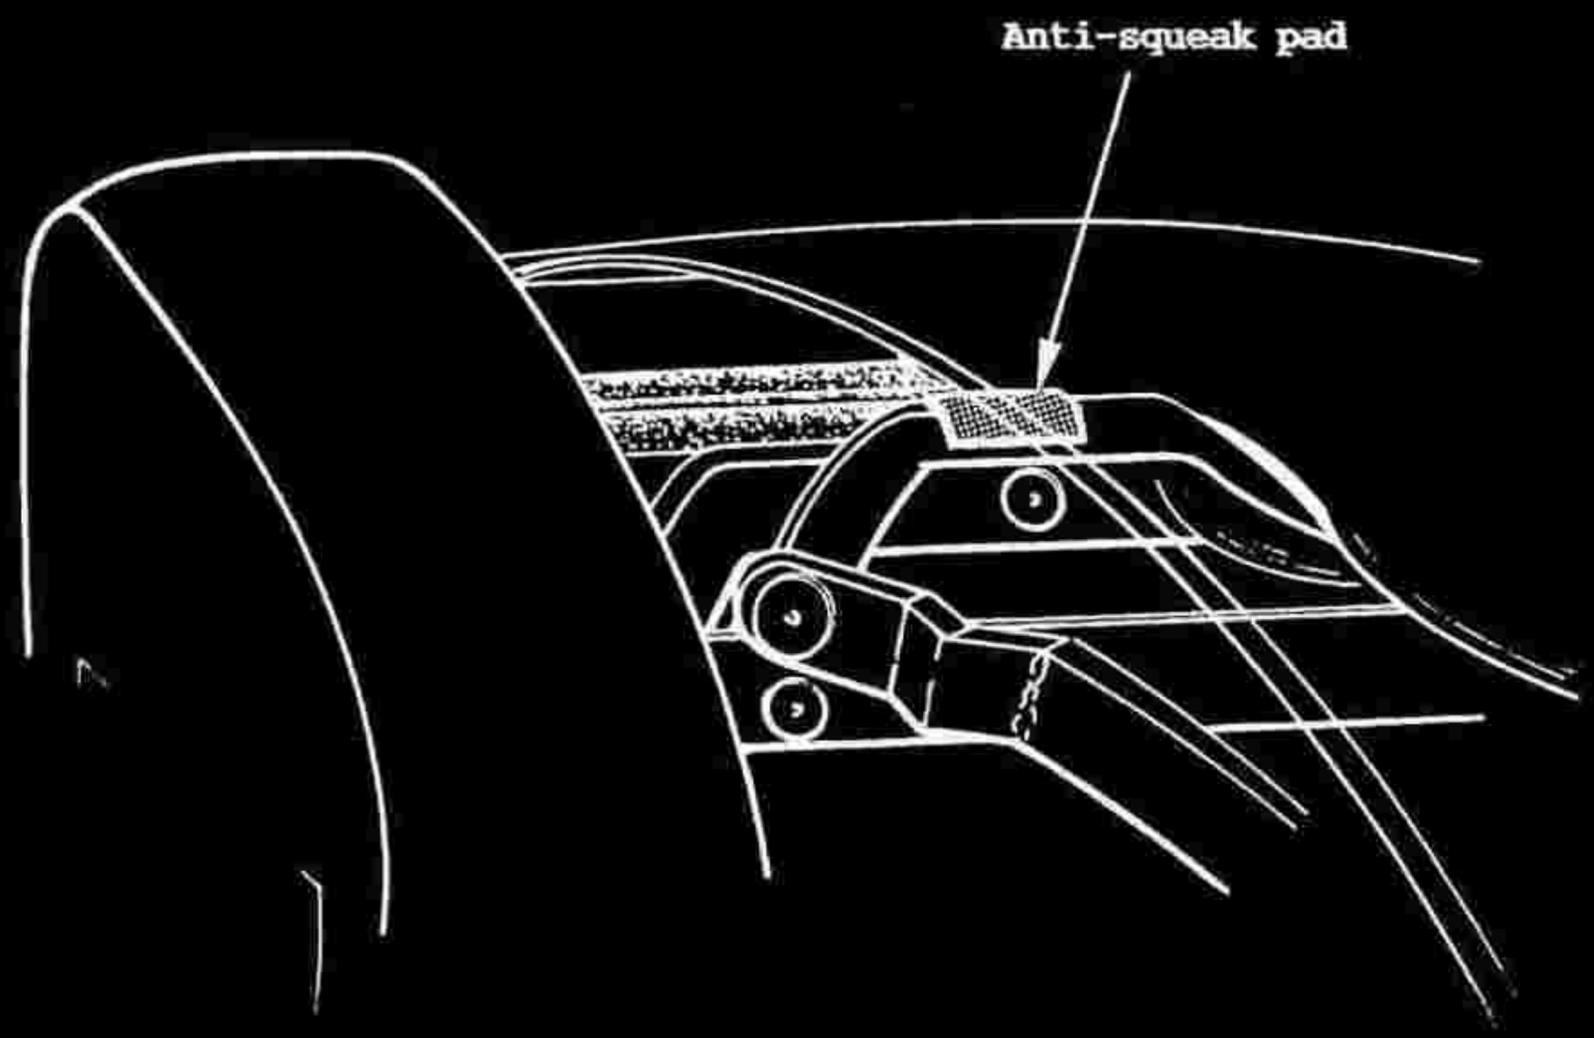
REASON: To prevent squeaking noises caused by contact between front edge of roof stowage lid and soft top support frame.

ACTION: If a squeaking noise on an Elan is found to be caused by the front lip of the roof stowage lid rubbing on the soft top support linkage, a self adhesive anti-squeak pad should be applied to each 'C' link as detailed below:

- At each side of the car, thoroughly clean the top surface of the 'C' link immediately below the front edge of the roof stowage lid, and mark the point of contact.
- Peel off the backing strip and stick a pad onto the roof link centrally about each contact point.
