Lotus Elan M100 Service Bulletins
Series 1 and Series 2 1990 - 1996

SERVICE BULLETIN

TITLE: Replacement of headlamp flap 'J' links.

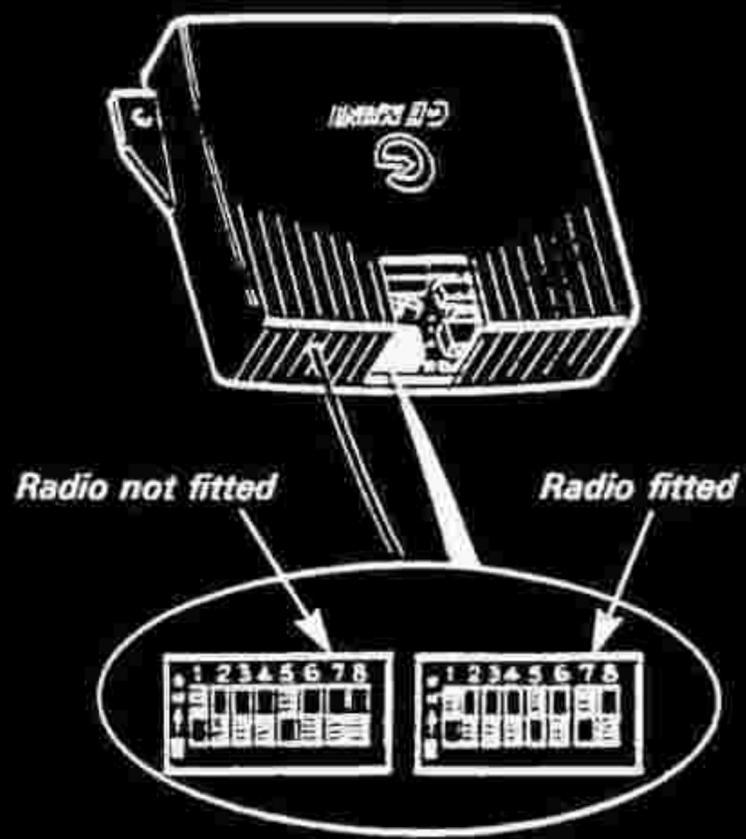
RHD cars: The radio alarm link is already fitted and earthed to the scuttle beam at the right hand end of the row of mini-relays, accessible beneath the binnacle cover. Release the lead and attach to the case of the audio set. Note that the alarm controller radio option switch is already set to the 'on' position.

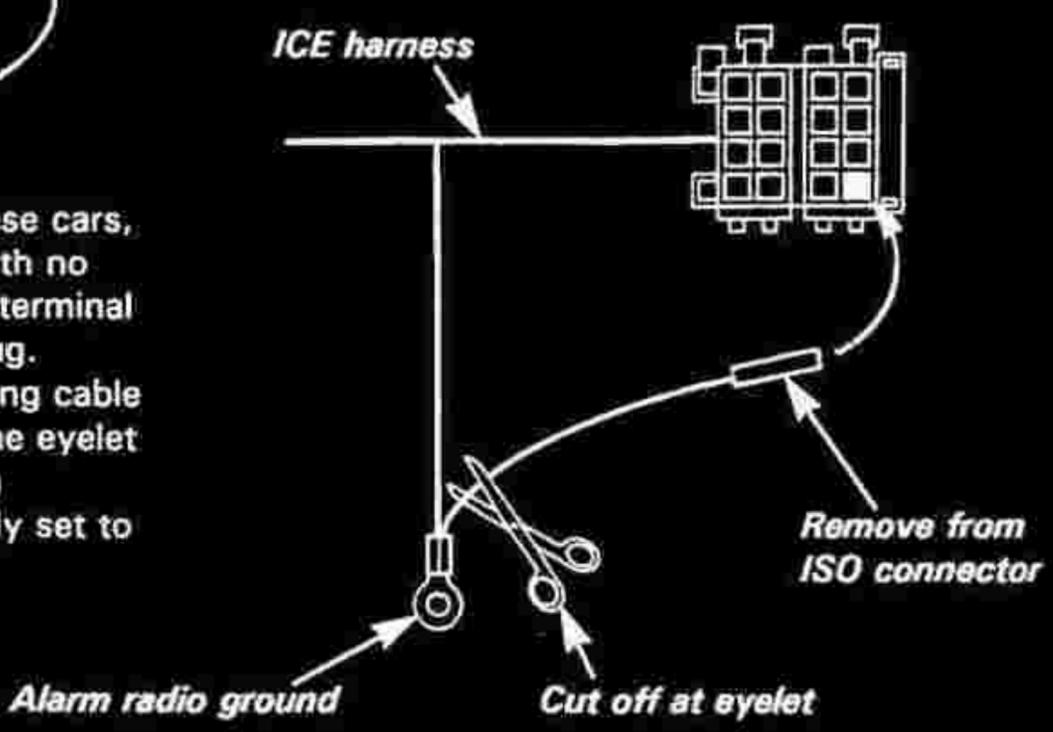
LHD cars (from VIN R 6165): On these cars, the radio harness eyelet is earthed (with no radio) via a bridging cable to an earth terminal in the radio harness ISO connector plug. When fitting a radio, unplug the bridging cable and cut off from the eyelet. Attach the eyelet to the radio case. Note that the alarm controller radio option switch is already set to the 'on' position.

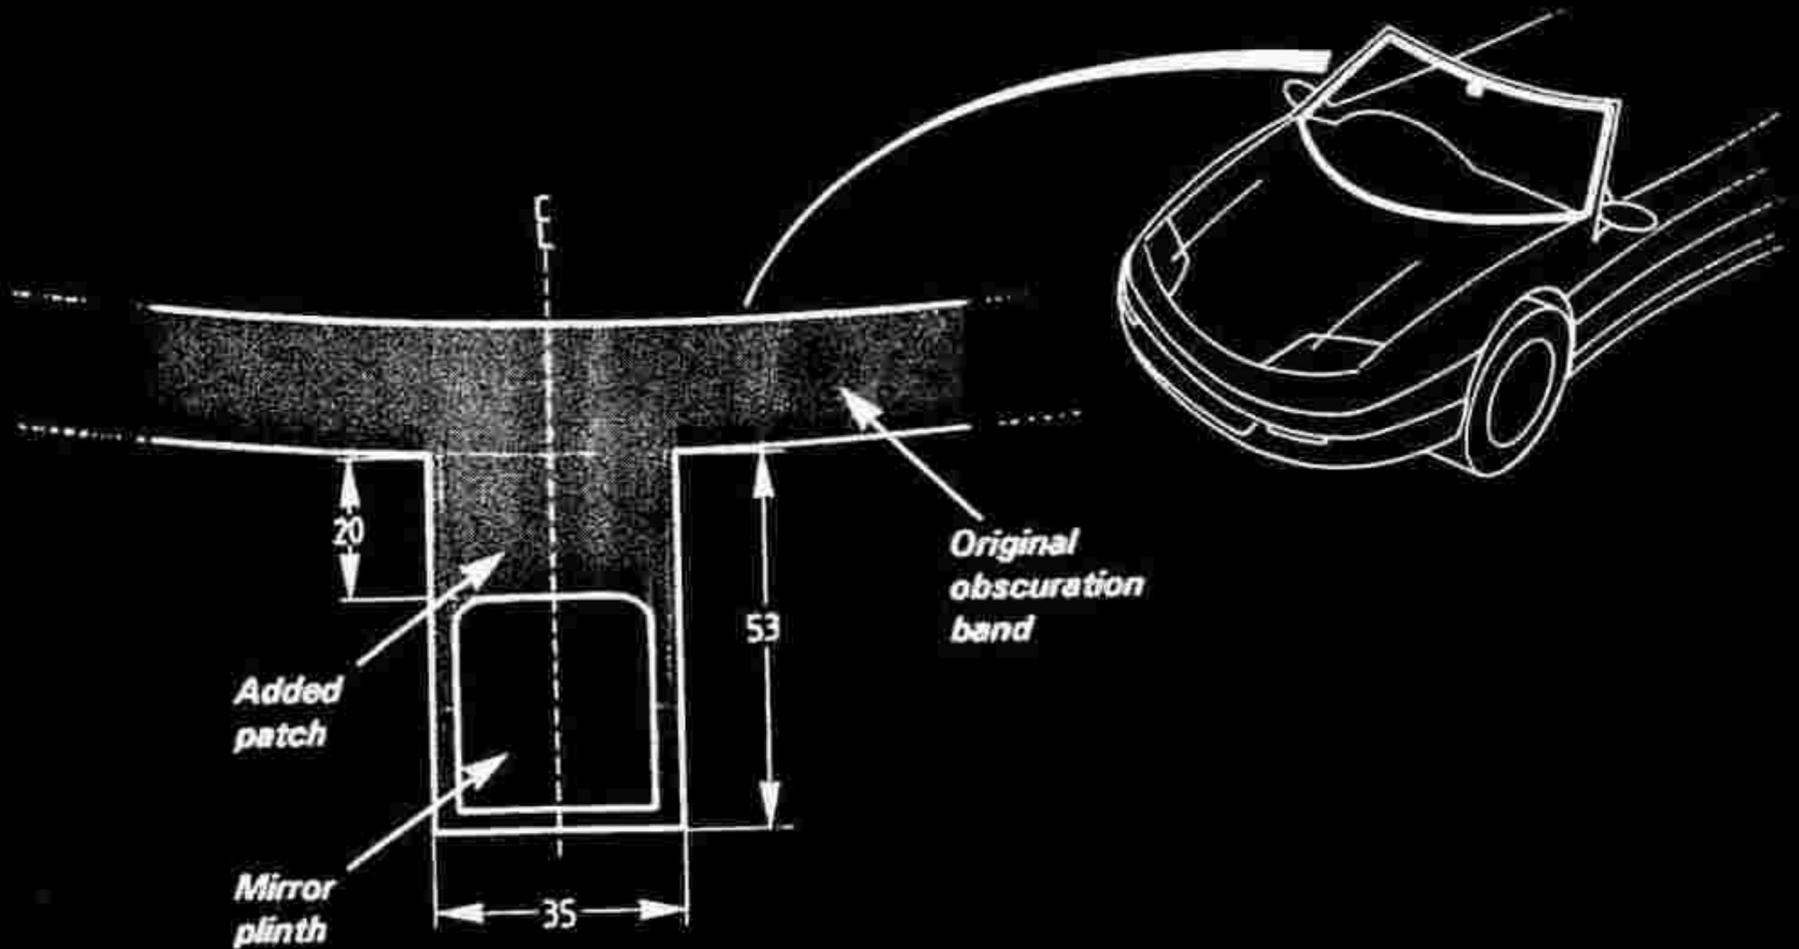
REASON: The obscuration band applied to the inside periphery of the windscreen by the screen manufacturer has been revised in order to increase resistance to stress related effects. As a consequence of this action, the patch obscuring the interior mirror plinth has been deleted. When fitting a replacement windscreen, this patch must be manually added using Betaseal primer.

ACTION: When fitting a windscreen to an Elan S1 or S2, refer to section BK.15 of the Elan Service Notes manual, but delay the glueing of the interior mirror plinth until after the Betaseal primer has been applied, with the following addition:

Use masking tape to mark out a rectangular patch extending down from the centre top of the screen obscuration band as shown in the diagram below. When the primer has fully dried, continue with the mirror plinth bonding as previously specified.

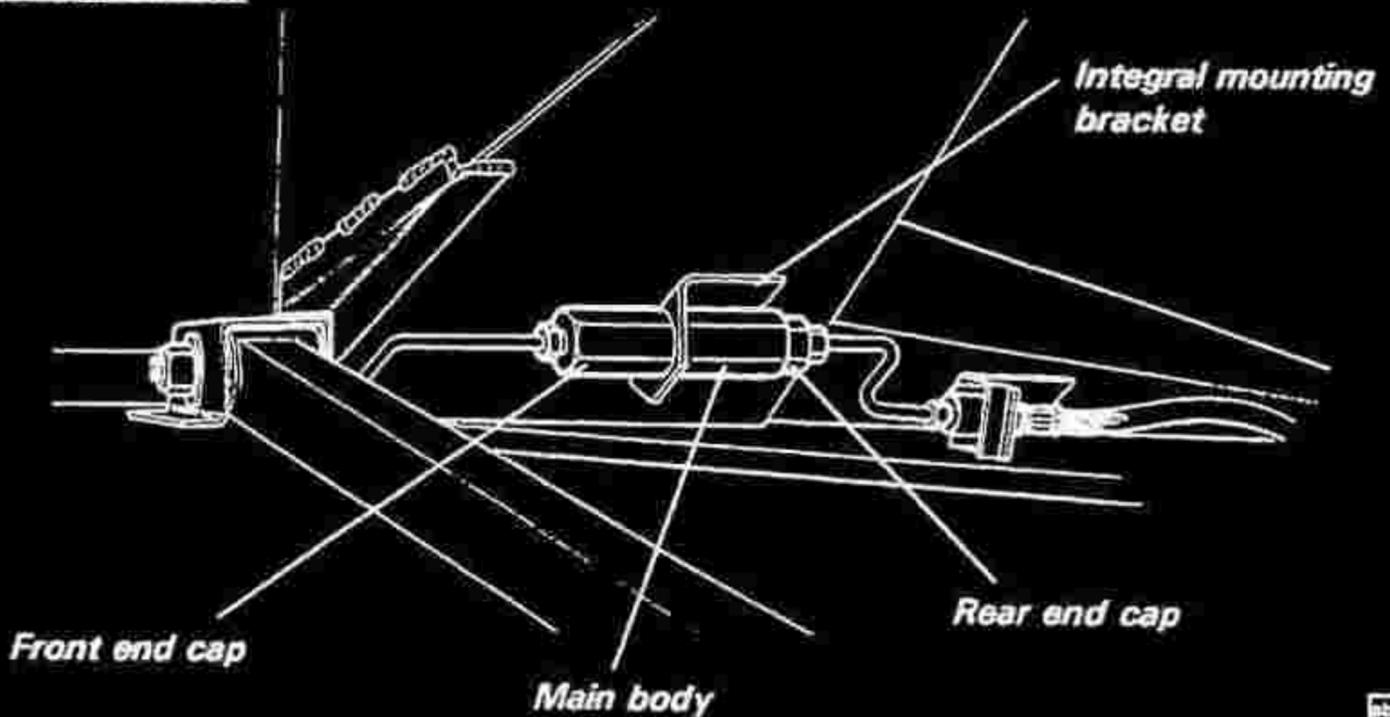
LH side shown

REASON: To reduce needless replacement of valves.
The brake pressure proportioning valves fitted to the rear brake circuits of Elan models, are sometimes erroneously diagnosed as leaking, due to their 'wet' appearance. This wetness is normal on a newly installed valve, and is due to the discharge of surplus polyalkylene glycol assembly fluid used during manufacture of the valve.

Right hand and left hand valve assemblies are identical, with the chassis fixing point differing to accommodate the asymmetric mounting bracket.
If submitting a warranty claim, the exact source and nature of the leak must be specified. Claims will not be paid if returned units are found to be fault free.

- Thoroughly degrease and clean the area before monitoring the appearance of any further wetness.
- Assess the colour of any 'leaked' fluid; assembly fluid is clear, brake fluid is amber.
- Check the level of fluid in the brake fluid reservoir; the level should fall progressively towards the 'min' mark as the pads wear in service.
